Kinematic Motion bushing repair kit for: 2000-2005 360 Spider and 2005-2009 Ferrari F430 Spider

Fits R.H. Rear Kinematic Motion with Ferrari part numbers 66457500

Fits L.H. Rear Kinematic Motion with Ferrari part numbers 66457300

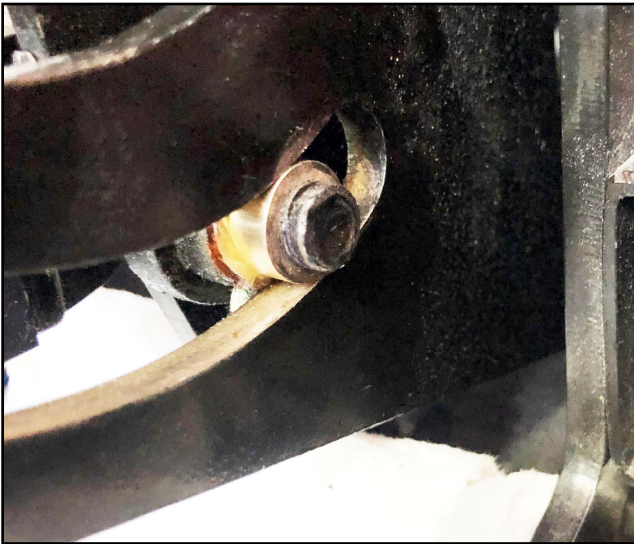
Replacement bronze bushing should move freely along entire groove.

The fit of the two new bronze bushings will be a much closer tolerance than the original bushings. It's very important to make sure they slide along in the grooves without any interference or friction. The fast tooling speed when the grooves were originally manufactured created a rough surface with cross hatch marks left behind. Before installing the bronze bushings, carefully file smooth out any rough surfaces and machining marks along the long groove left over from during manufacturing using a fine half-round needle file or similar tool. Test the groove clearances by hand by sliding the bushings several times along inside the entire groove length. Be sure to test fit the hooked shaped curve at the end. The bushing should not be restricted to any part of the hook at the end. Hold the bushing in between with your thumb and middle finger while the bushing travels along. Do not file the bronze bushings because they will mar the groove surface during usage and impact the lifespan of the parts. Because of the proximity to engine heat, be sure to use take into consideration the temperature rating of the grease used in the groove when installing the bronze bushings.

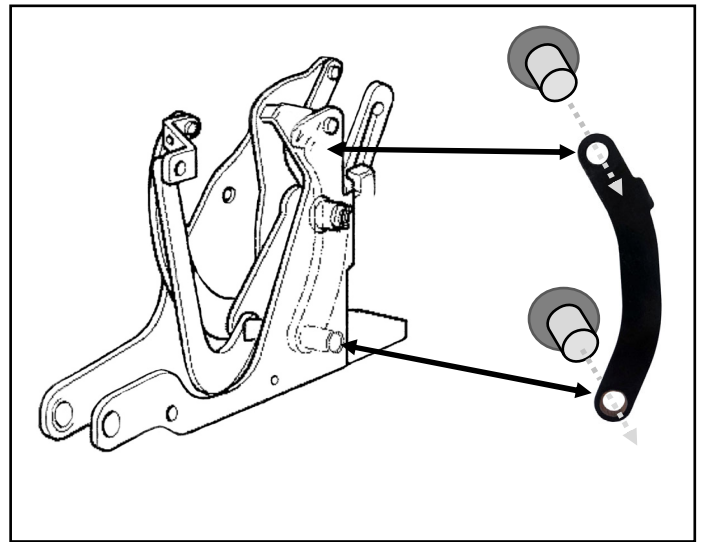
Fulcrum arm location inside the kinematic motion.

The original bushings for the fulcrum arms can be difficult to remove. Vice grip pliers and a twisting motion may work. Once the split end of the old bushing comes loose, you can curl it into a small spiral with needle nose pliers. Don't hammer in the new bushings. You can press in the new ones with a 1-ton hand operated shop press with very little effort and minimize any damage to the bushings. The main repair is to replace the bronze bushings. Split bushing replacement may be optional depending on how much wear they have. Having a magnetic retrieval tool will help catch or recover dropped clips. The top pins are non-ferrous so use care not to drop under the engine. Please follow proper F430 workshop repair manual procedures from Ferrari.

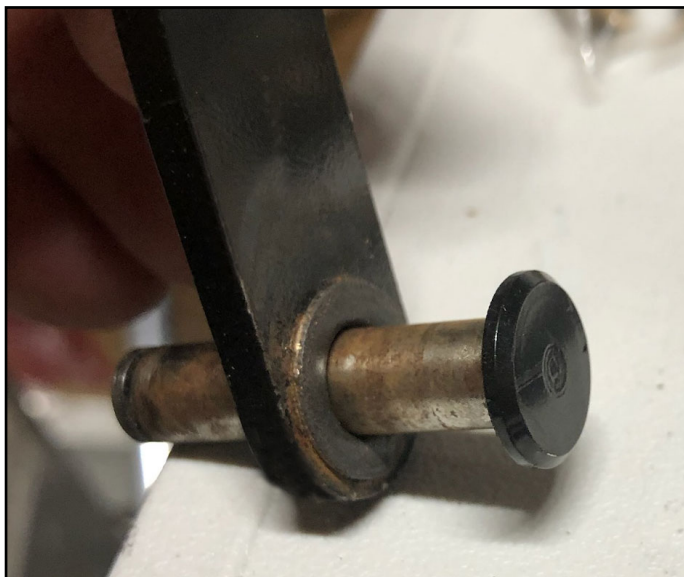
Close up of fulcrum arm.

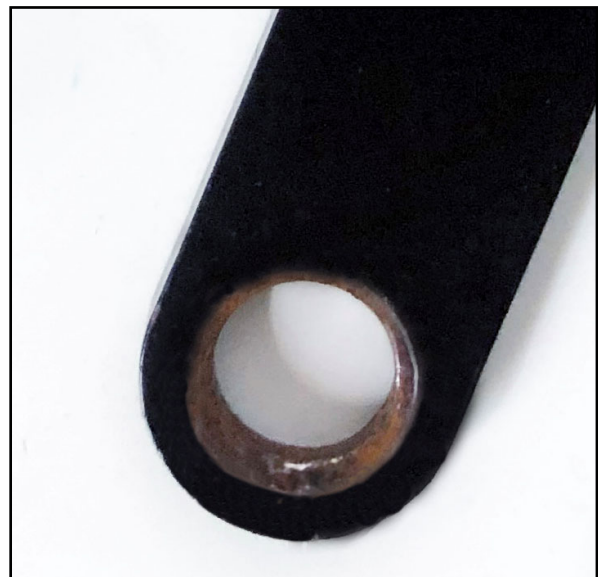
Close up of fulcrum arm with factory bushing removed
